Why Indeed Did the WTC Buildings Completely Collapse?

By Dr. Steven E. Jones

In this paper, I call for a serious investigation of the hypothesis that WTC 7 and the Twin Towers were brought down, not just by impact damage and fires, but through the use of pre-positioned cutter-charges. I consider the official FEMA, NIST, and 9-11 Commission reports that fires plus impact damage alone caused complete collapses of all three buildings. And I present evidence for the controlled-demolition hypothesis, which is suggested by the available data, and can be tested scientifically, and yet has not been analyzed in any of the reports funded by the US government.

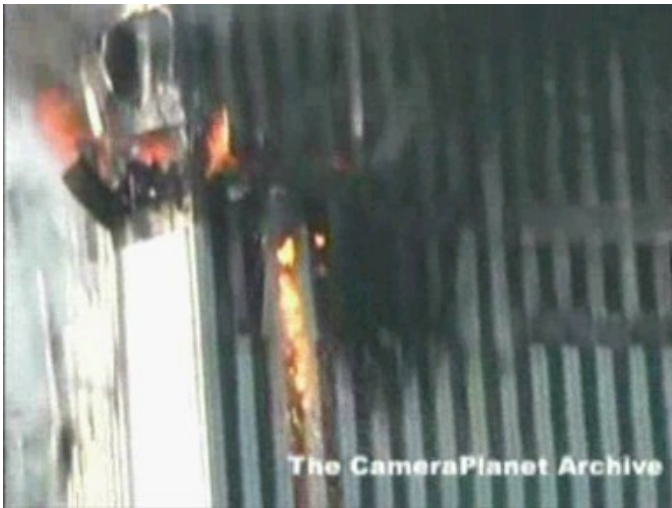
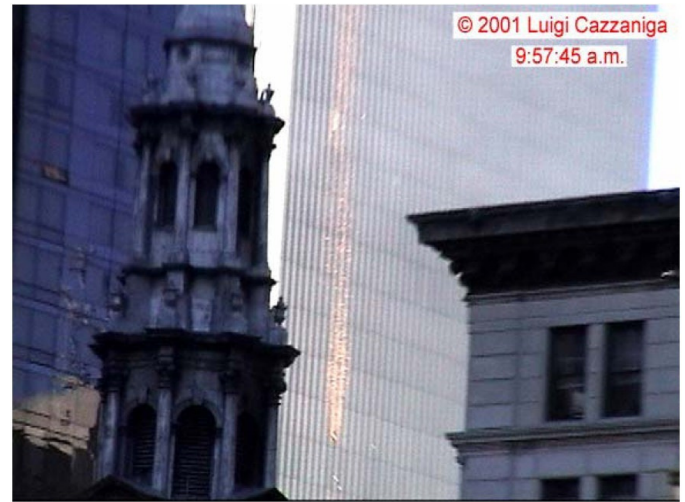
Is the falling molten metal from WTC Tower 2 (Top photos) more likely molten iron from a thermite reaction (lower left) OR pouring molten aluminum (lower right)?

Who can deny that liquid, molten metal existed at the WTC disaster? The yellow color implies a molten-metal temperature of approximately 1000 °C, evidently above that which the dark-smoke hydrocarbon fires in the Towers could produce. If aluminum (e.g., from the plane) had melted, it would melt and flow away from the heat source at its melting point of about 650 °C and thus would not reach the yellow color observed for this molten metal. Thus, molten aluminum is already ruled out with high probability. But molten iron with the characteristics seen in this video is in fact consistent with a thermite-reaction attacking the steel columns in the Tower, thus weakening the building just prior to its collapse, since thermite produces molten iron at yellow-to-white hot temperatures. (As some of the molten metal hits the side of the building in the video clip above, the white-hot interior is evidently exposed as the metal "splashes".) Also, the fact that the liquid metal retains an orange hue as it nears the ground (right photograph) further rules out aluminum, and suggests a mid-flight thermite reaction (typical of thermite). Here are two independent videos of the yellow-white liquid metal pouring out of the South Tower: <http://video.google.com/videoplay?docid=->

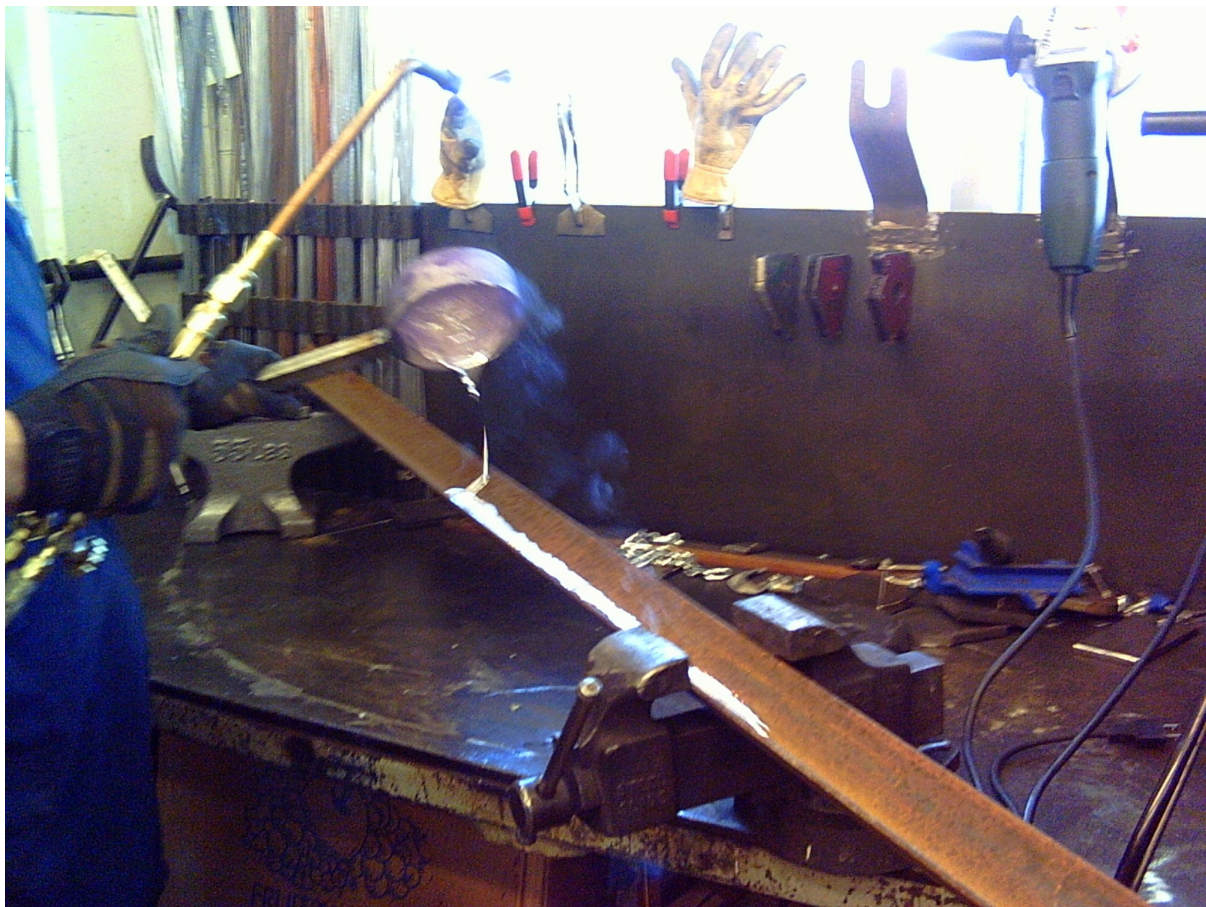
Molten aluminum poured onto rusted steel: silvery flow, and **no** violent reactions observed at all (contrary to predictions by some of a vigorous aluminum-rust “thermic reaction”). Same result -- when the rusty steel piece was pre-heated with the torch.

We also noted that while a steel pan holding the aluminum glowed red and then yellow hot, when poured out the falling aluminum displayed a silvery-gray color, adding significantly to the evidence that the yellow-white molten metal flowing out from the South Tower shortly before its collapse was NOT molten aluminum. (Recall also that the yellow color of the molten metal (video clip above) implies a temperature of approximately 1100°C -- too high for the dark-smoke hydrocarbon fires burning in the building.) This is a point worth emphasizing: aluminum has low emissivity and high reflectivity, so that in daylight conditions after falling through air 1-2 meters, molten aluminum will appear silvery-gray, while molten iron (with its characteristic high emissivity) will appear yellow-white (at ~1100°C) as observed in the molten metal dripping from the South Tower just before its collapse (see: <http://www.supportthetruth.com/jones.php>). We also recall that this molten metal, after falling approximately 150 meters (or yards) still retained a reddish orange color (photograph above). This is not the behavior of falling, molten aluminum.

NIST states the hypothesis that flowing aluminum with partially burned organic materials mixed in, "can display an orange glow." But will it really do this? I decided to do an experiment to find out. Our group melted aluminum in a steel pan using an oxy-acetylene torch. Then we added plastic shavings -- which immediately burned with a dark smoke, as the plastic floated on top of the hot molten aluminum. Next, we added wood chips (pine, oak and compressed fiber board chips) to the liquid aluminum. Again, we had fire and smoke, and again, the **hydrocarbons floated on top** as they burned. We poured out the aluminum and all three of us observed that it appeared silvery, not orange! We took photos and videos, so we will have the recorded evidence as these are processed. Of course, we saw a few burning embers, but this did not alter the silvery appearance of the flowing, falling aluminum.

We decided to repeat the experiment, with the same aluminum re-melted. This time when we added fresh wood chips to the hot molten aluminum, we poured the aluminum-wood concoction out while the fire was still burning. And as before, the wood floated on top of the liquid aluminum. While we could see embers of burning wood, we observed the bulk of the flowing aluminum to be silvery as always, as it falls through the air.

This is a key to understanding why the aluminum does not "glow orange" due to partially-burned organics "mixed" in (per NIST theory) - because they do NOT mix in! My colleague noted that it is like oil and water - organics and molten aluminum do not mix. The hydrocarbons float to the top, and there burn - and embers glow, yes, but just in spots. The organics clearly do NOT impart to the hot liquid aluminum an "orange glow" when it falls, when you actually do the experiment! Videos of our experiments involving organics added to liquid aluminum are available here: <http://www.scholarsfor911truth.org/Experiments-to-test-NIST-orange-glow-hypothesis.html>

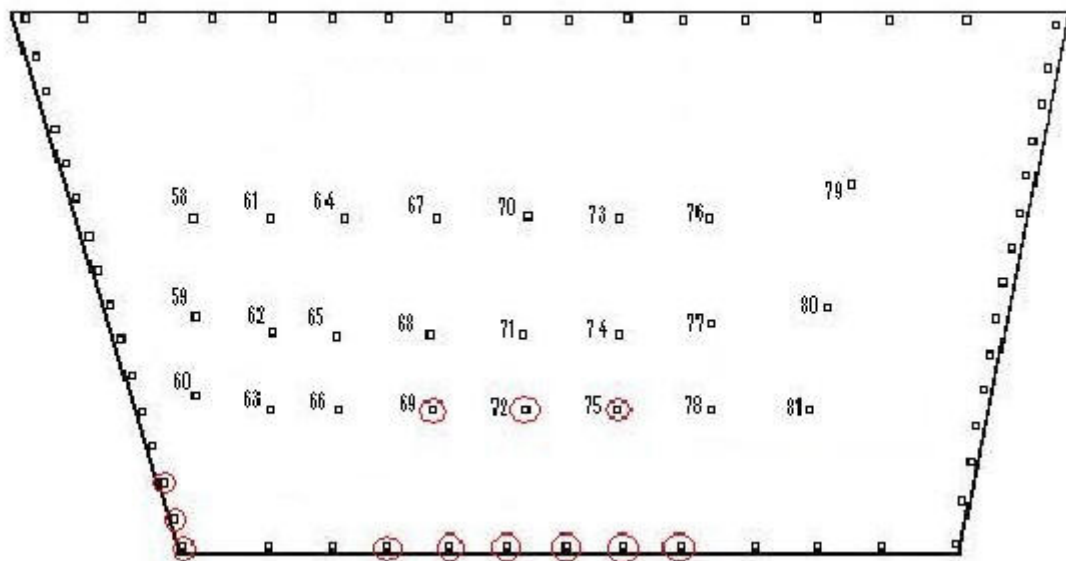
Diagram showing steel-column arrangement in WTC 7, view looking down on the roof. Circled columns were possibly damaged due to debris from WTC 1 collapse, some 350 feet away (NIST, 2005) so the damage was clearly non-symmetrical, and evidently, none of the core columns was severed by falling debris. WTC 7 was never hit by a plane.

As you observed (link above), WTC 7 collapsed rapidly and nearly-straight-down symmetrically -- even though fires were randomly scattered in the building. WTC 7 fell about seven hours after the Towers collapsed, even though no major persistent fires were visible (considerable dark smoke was seen). There were twenty-four huge steel support columns inside WTC 7 as well as huge trusses, arranged non-symmetrically, along with some fifty-seven perimeter columns, as indicated in the diagram below (FEMA, 2002, chapter 5; NIST, 2005).

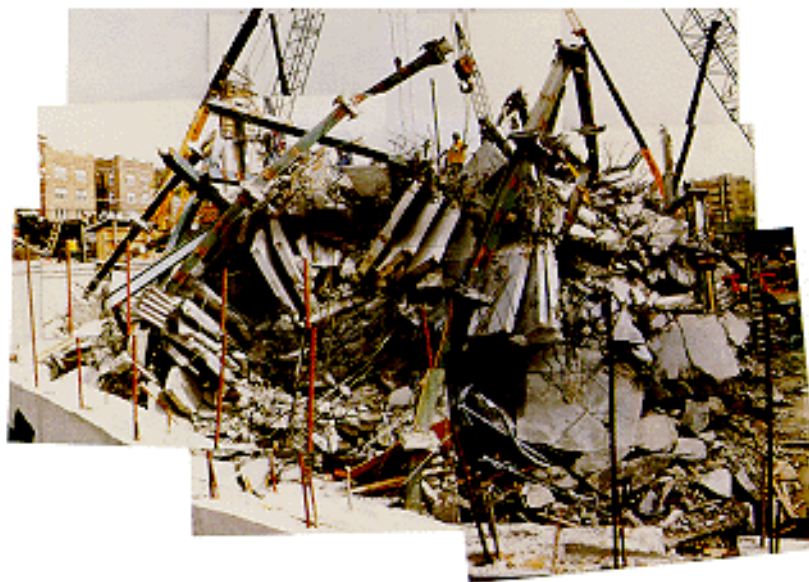
Non-symmetrical collapse of tall buildings when due to random causes. L'Ambiance Plaza collapse (right) shows how pancaked concrete floor slabs are largely intact and clearly reveal stacking effects with minimal fine dust, as expected from random progressive collapse. By contrast, concrete floors in the Twin Towers and WTC 7 were pulverized to dust -- as is common in controlled demolitions using explosives.

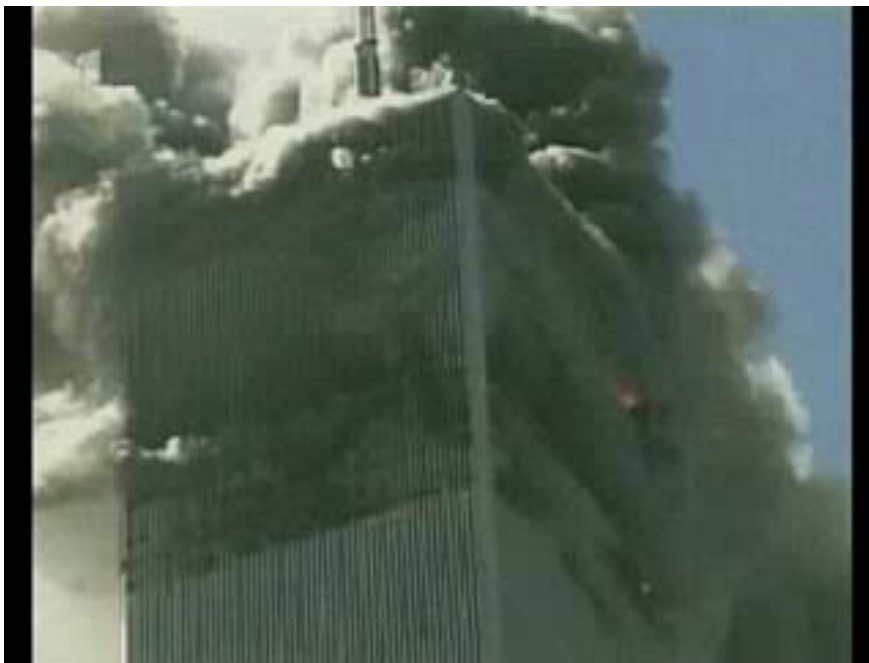
North Tower showing antenna (top) at beginning of collapse.

Review of videotape recordings of the collapse taken from various angles indicates that the transmission tower on top of the structure began to move downward and laterally slightly before movement was evident at the exterior wall. This suggests that **collapse began with one or more failures in the central core area of the building.** (FEMA, 2002, chapter 2; emphasis added.)

Yes, we can see for ourselves that the antenna drops first from videos of the North Tower collapse. (See http://911research.wtc7.net/wtc/evidence/videos/wtc1_close_frames.html; also <http://home.comcast.net/~skydrifter/collapse.htm>.) A NY Times article also notes this behavior:

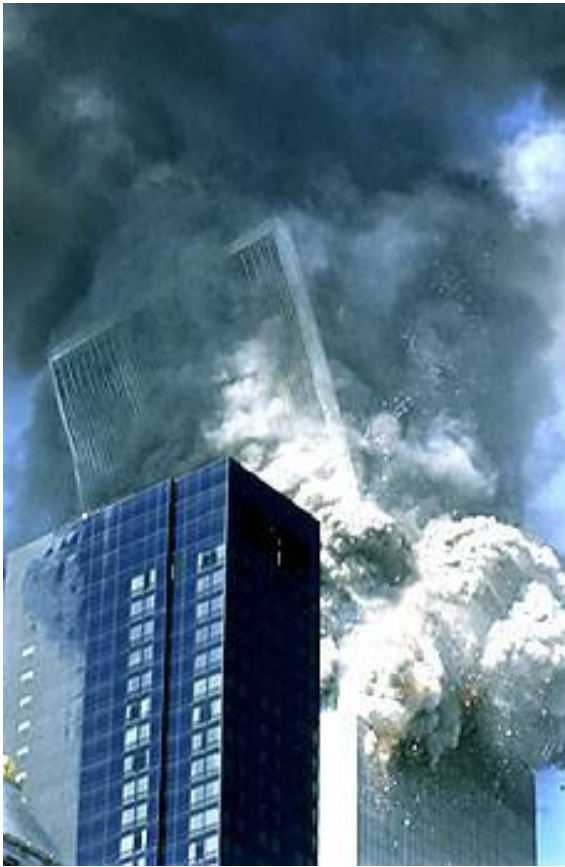
Top ~ 30 floors of South Tower topple over.
What happens to the block and its angular momentum?

We observe that approximately 30 upper floors begin to rotate as a block, to the south and east. They begin to topple over, not fall straight down. The torque due to gravity on this block is enormous, as is its angular momentum. But then – and this I’m still puzzling over – this block turned mostly to powder *in mid-air*! How can we understand this strange behavior, without explosives? Remarkable, amazing – and demanding scrutiny since the US government-funded reports failed to analyze this phenomenon. But, of course, the Final NIST 9-11 report “**does not actually include the structural behavior of the tower after the conditions for collapse initiation were reached.**” (NIST, 2005, p. 80, fn. 12; emphasis added.)
